ON-SITE AIR BAG INVESTIGATION

CASE NO. - 94-09

LOCATION - [REDACTED] KENTUCKY

The front left of the Corsica impacted the front left of the C-1500 pickup. The CDCs were determined to be: 12-FLAE-7 for the Corsica and 12-FYEW-5 for the C-1500. The CRASHPC reconstruction program, damage and trajectory algorithm, was used on the impact (highest severity) to the Corsica. The Total, Longitudinal, and Lateral Delta Vs are respectively: 35 k.p.h. (22 m.p.h.), -35 k.p.h. (-22 m.p.h.), and +0 k.p.h. (+0 m.p.h.).

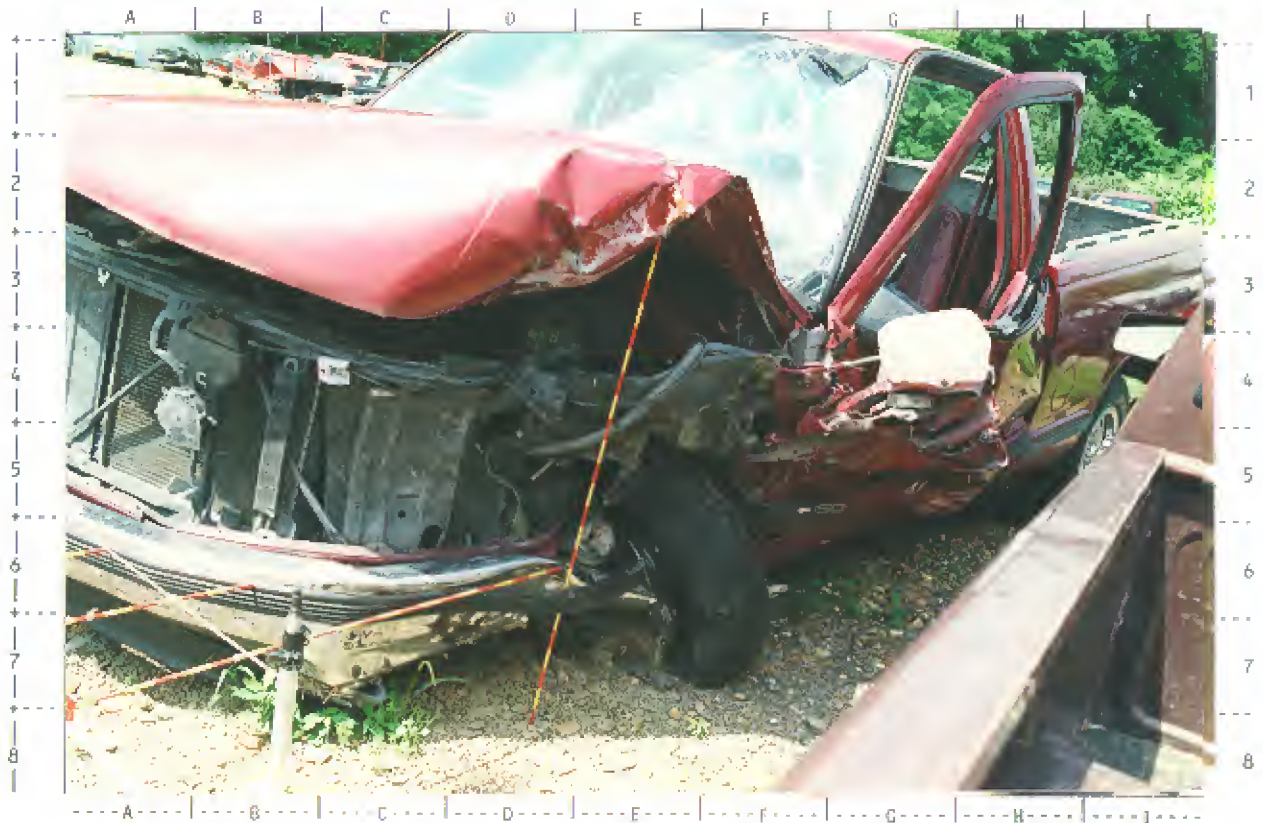
65 -- Front left view of damage to 1988 Chevrolet pickup; NOTE: hood damage (cells D2--E3) from contact with '91 Corsica's A-pillar

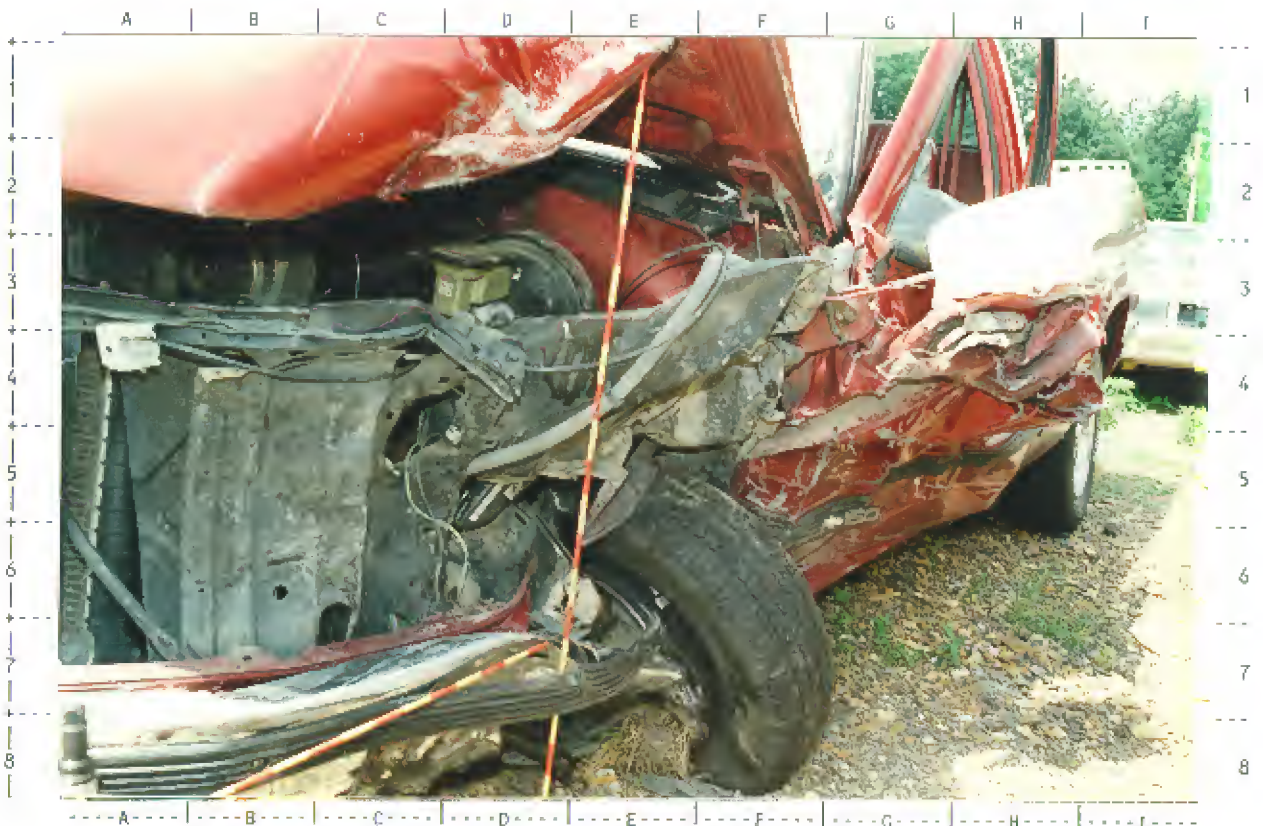
66 -- Front left close-up of damage to 1988 Chevrolet pickup; NOTE: damage to FL hood, LF wheel, & continuation along left side

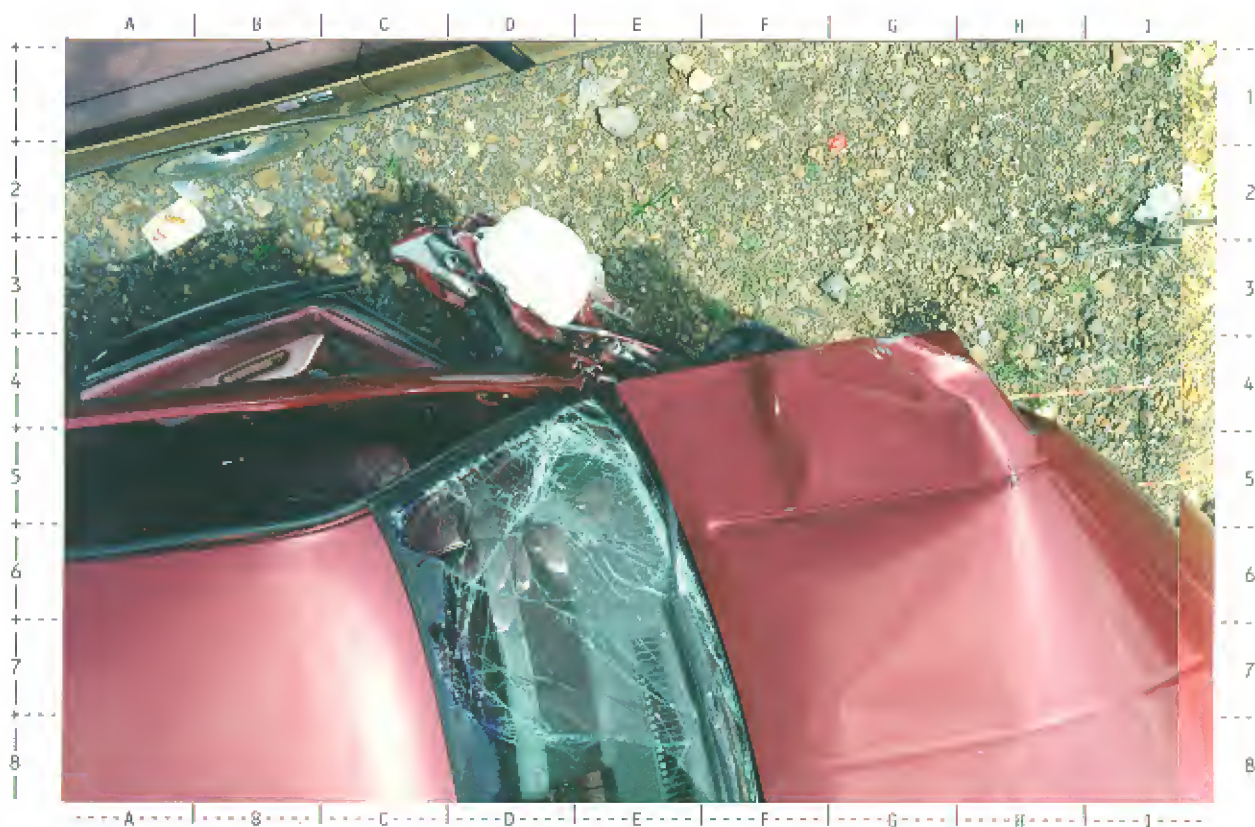
67 -- Overhead left front view of damage to '88 Chevrolet C-1500 pickup; NOTE: stress cracks to left windshield

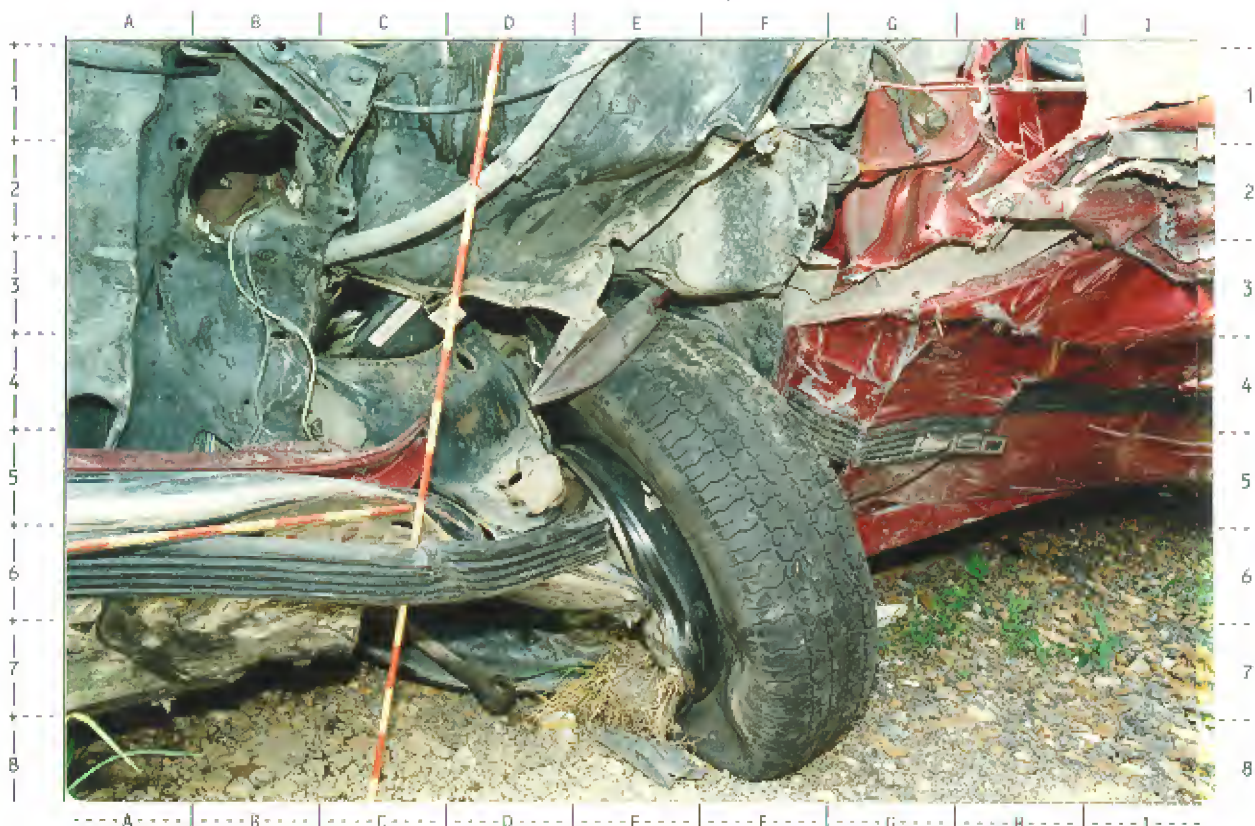
68 -- Close-up of 1988 Chevrolet pickup's left front wheel damage; NOTE: broken steering rod and grass & mud in wheel rim

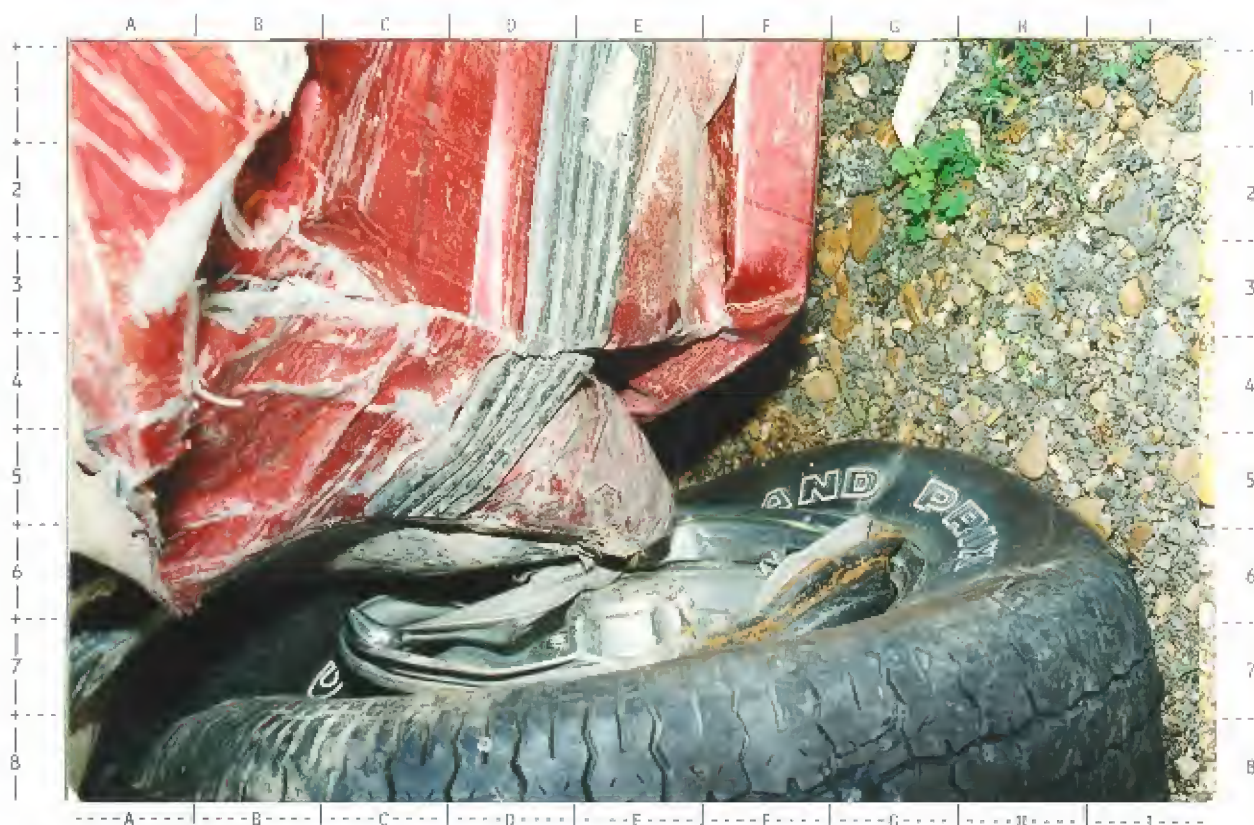
69 -- Close-up of direct damage to 1988 Chevrolet pickup's LF rim and also behind displaced left front wheel--viewed from left

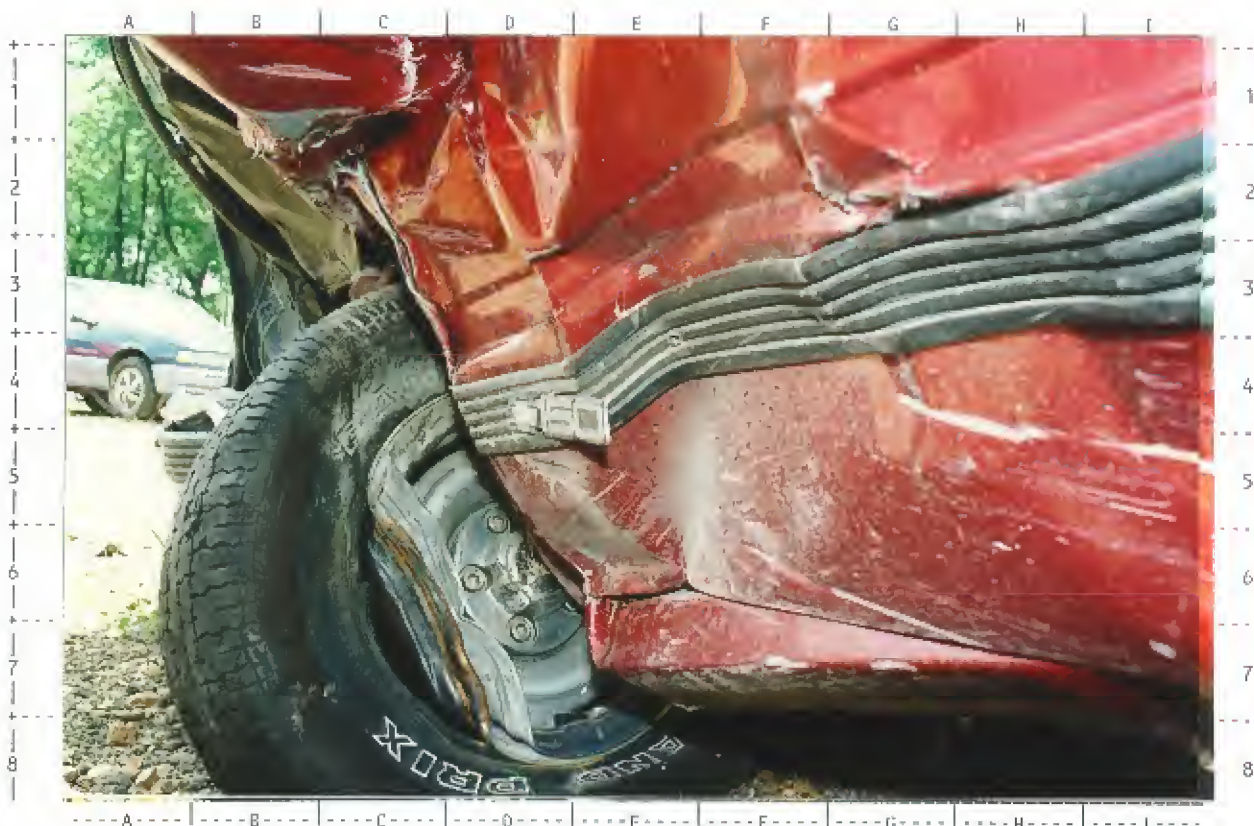
70 -- Close-up of direct damage to 1988 Chevrolet pickup's LF rim and also behind displaced left front wheel--viewed from back left

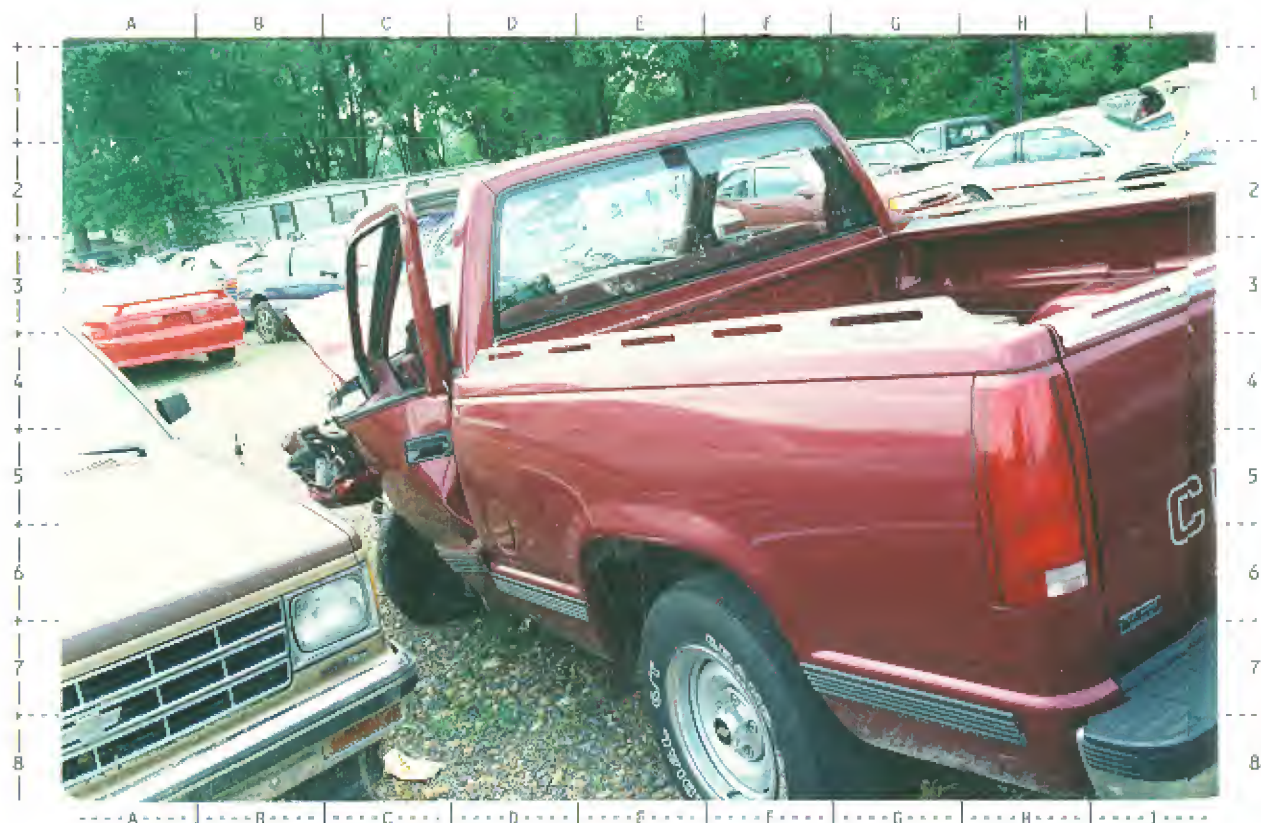
71 -- Left back view of 1988 Chevrolet C-1500 pickup; NOTE: outward bowing to left front (driver's) door & induced cargo bed damage

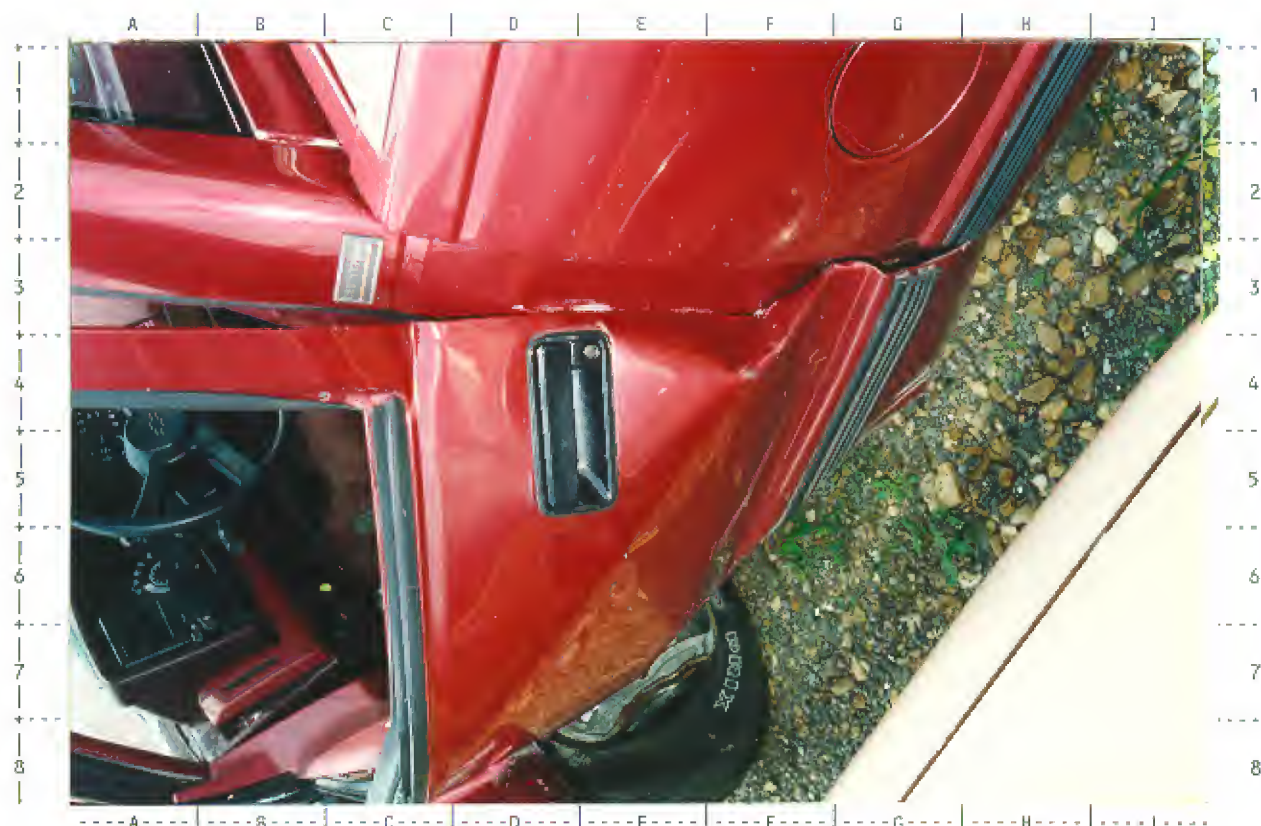
72 -- Close-up of '88 Chevrolet C-1500 pickup's outwardly bowed LF door; NOTE: latch & striker are still holding door closed

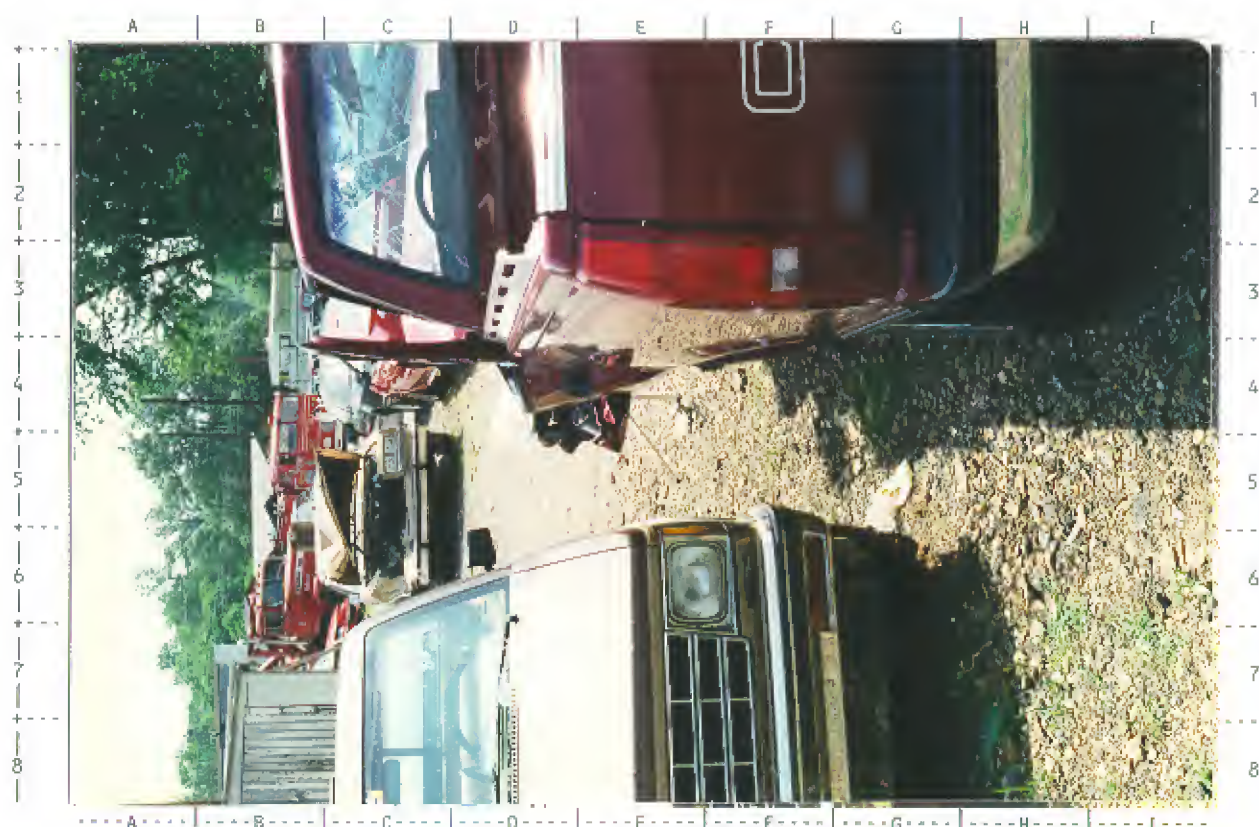
73 -- Left side reference line viewed from back shows frontal damaged to 1988 Chevrolet pickup; NOTE: undamaged back left corner

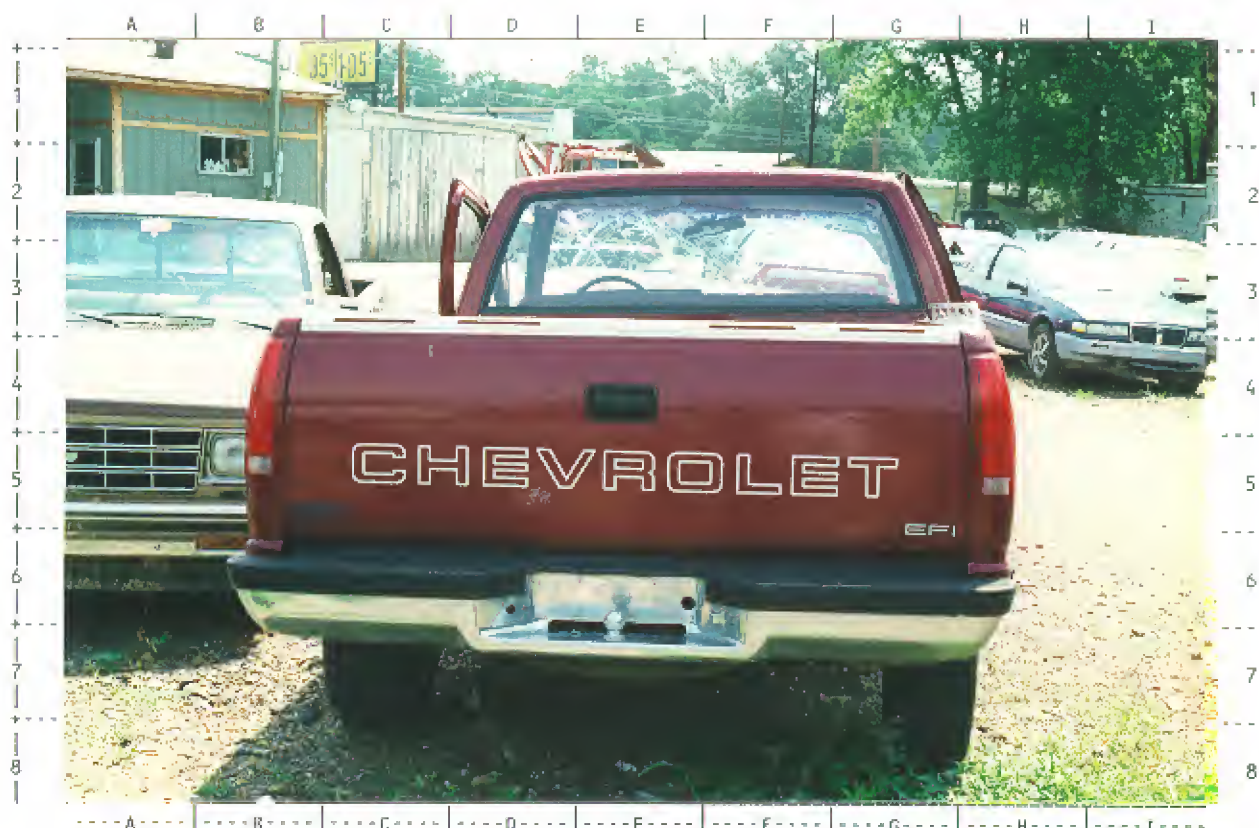
74 -- Back view of 1988 Chevrolet C-1500 pickup showing undamaged back side; NOTE: driver's door window frame is bent outwards

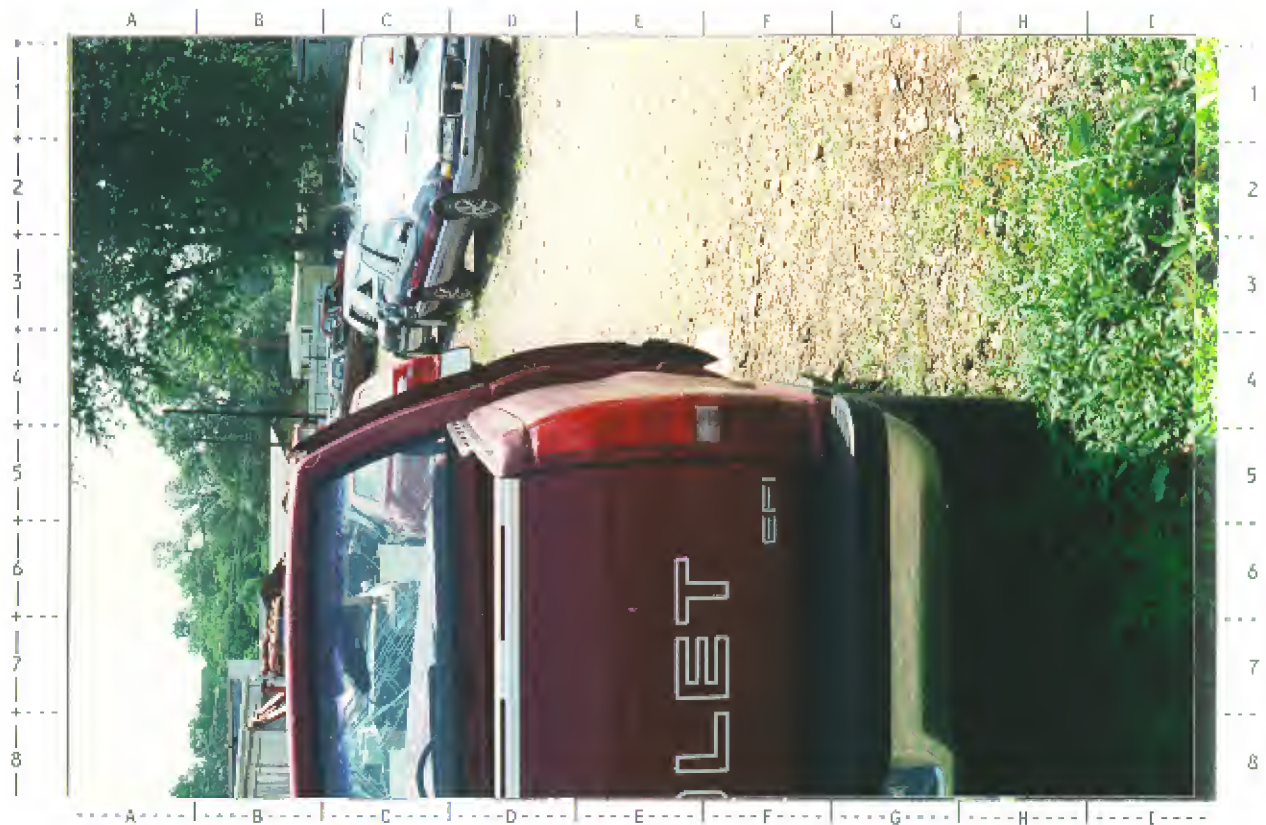
75 -- Right side reference line viewed from back shows induced damage to 1988 Chevrolet pickup; NOTE: shift between cab & cargo box

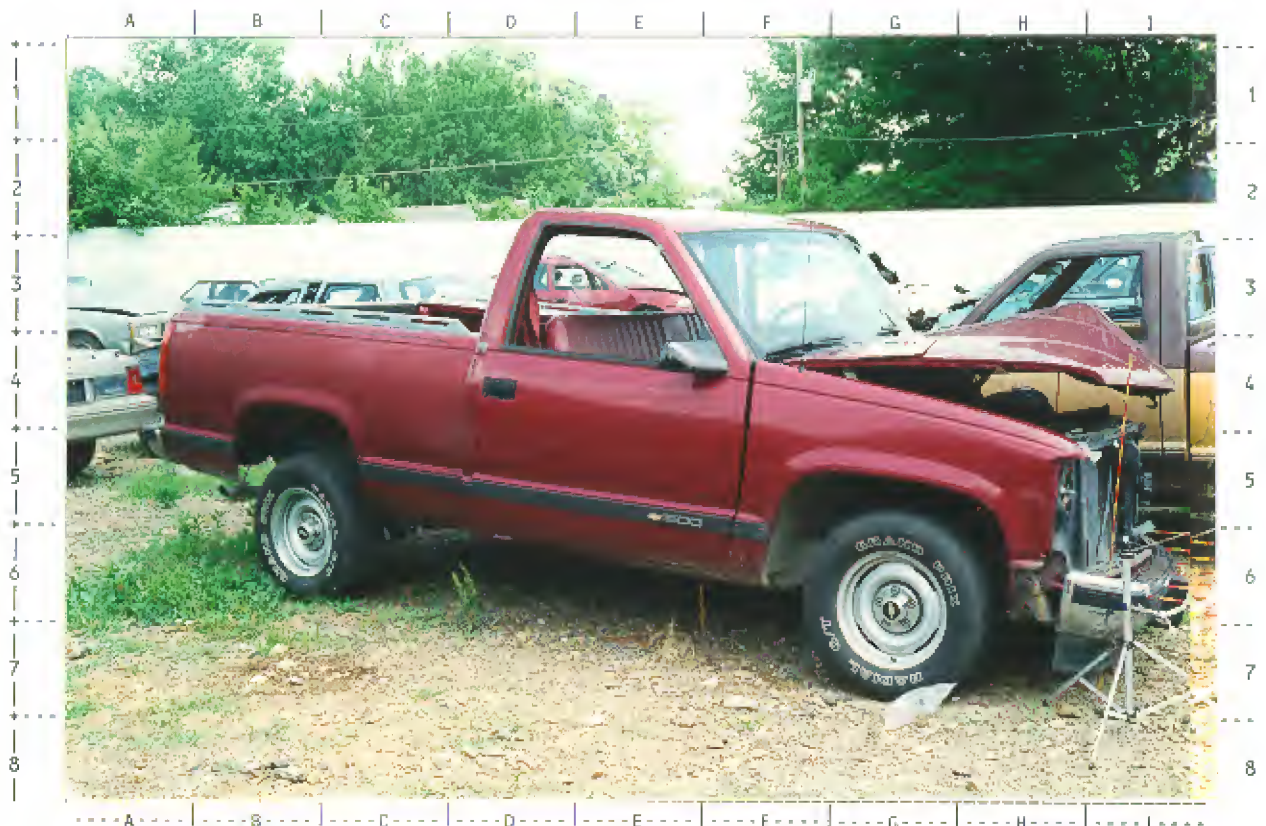
76 -- Right side view of 1988 Chevrolet C-1500 pickup showing undamaged right side except for induced damage to right front door

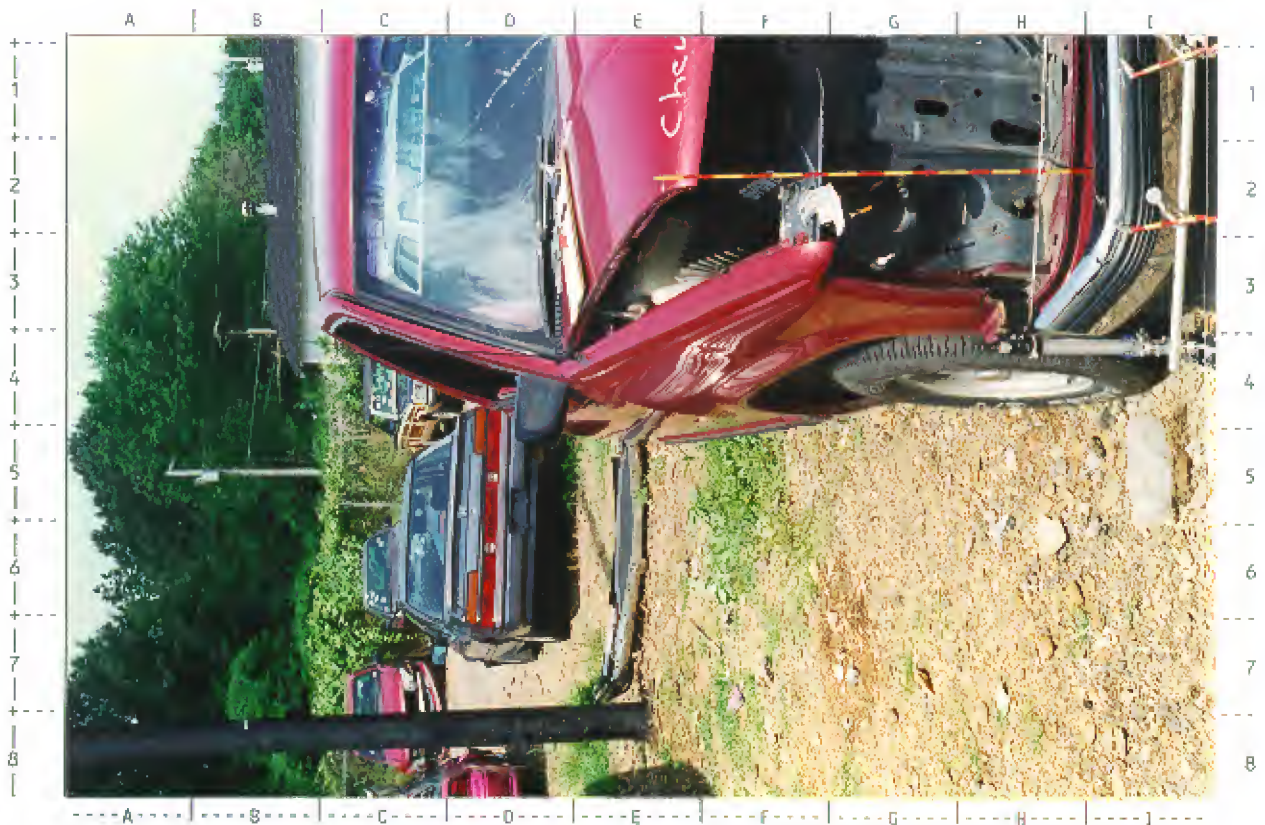
77 -- Right side reference line viewed from front does not show any damage to 1988 Chevrolet C-1500 pickup

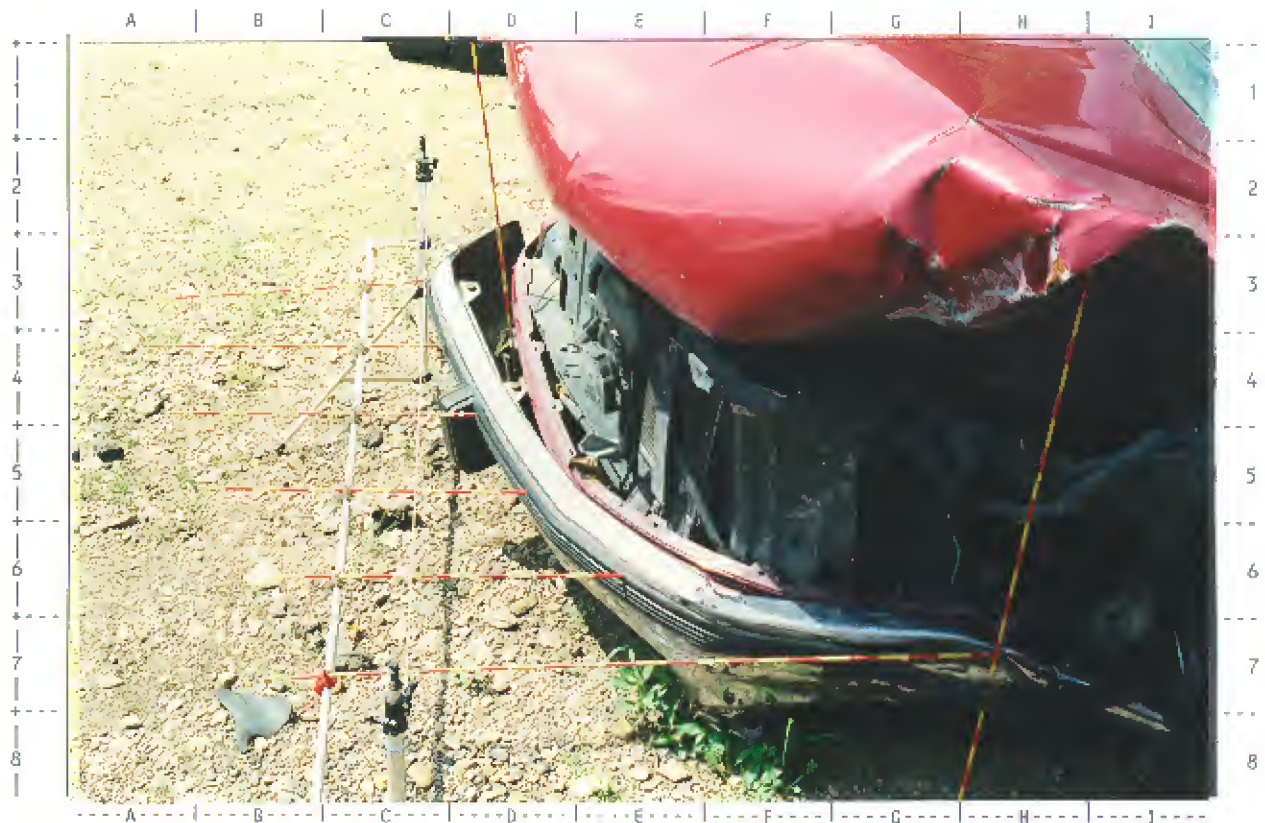
79 -- Front reference line viewed from L with contour guage present shows damage to front left corner of '88 Chevrolet C-1500 pickup

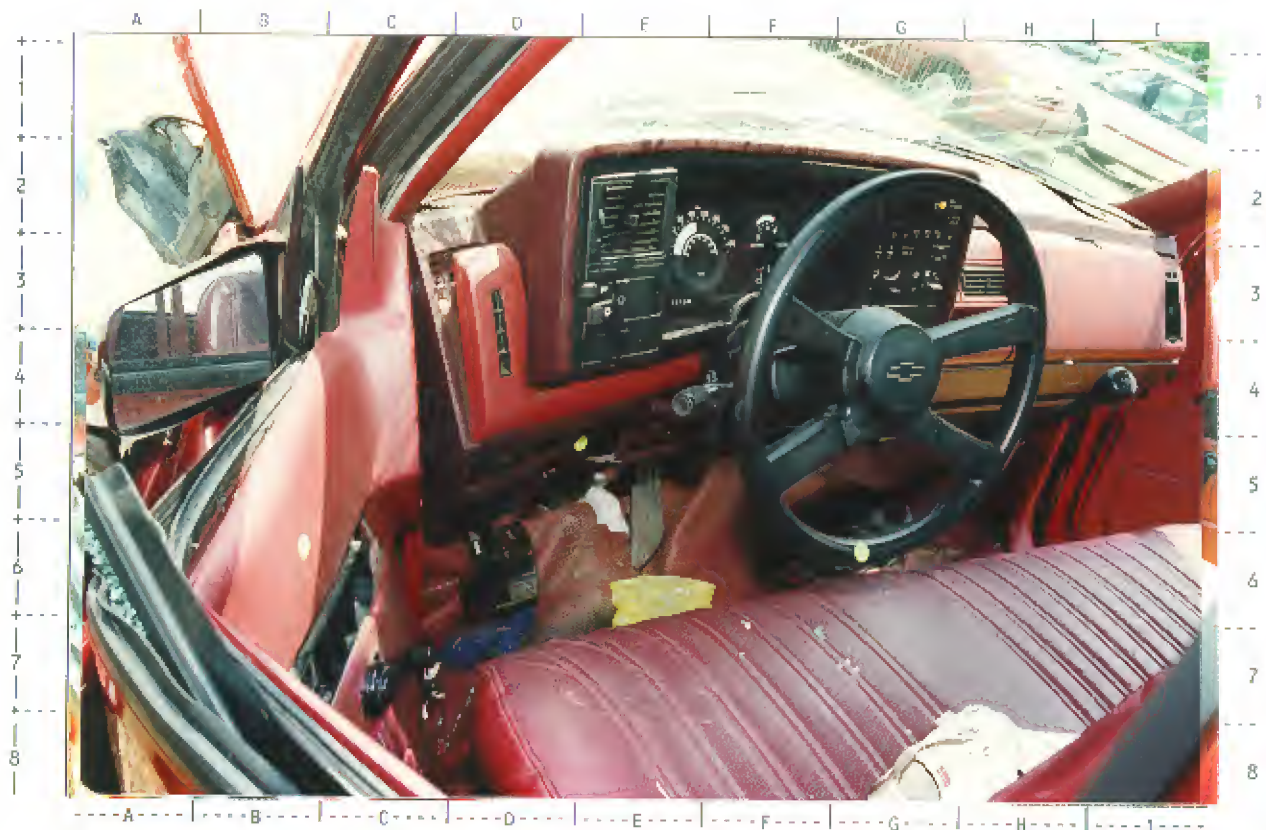
81 -- Interior view of driver's area of 1988 Chevrolet pickup; NOTE: contacts (dots) to door panel, steering wheel, & lower dash
